# Intel<sup>®</sup> Pentium<sup>®</sup> 4 Processor Specification Update

Release Date: January 2002

Order Number: 249199-018

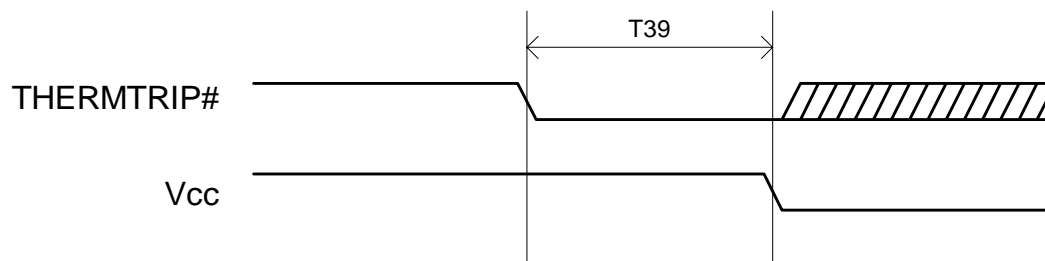
The following figure will be added as Figure (new). THERMTRIP# Power Down Sequence

<u>T# Parameter</u>	<u>Min</u>	<u>Max</u>	<u>Unit</u>	<u>Figure</u>	<u>Notes</u>
T39: THERMTRIP# to removal of power	N/A	500	ms	(new)

$T39 < 0.5$  seconds

Note: THERMTRIP# is undefined when RESET# is active

Assertion of THERMTRIP# (Thermal Trip) indicates the processor junction temperature has reached a level beyond which permanent silicon damage may occur. Measurement of the temperature is accomplished through an internal thermal sensor which is configured to trip at approximately 135°C. Upon assertion of THERMTRIP#, the processor will shut off its internal clocks (thus halting program execution) in an attempt to reduce the processor junction temperature. To protect the processor, its core voltage ( $V_{CC}$ ) must be removed following the assertion of THERMTRIP#. See Figure (new) and Table 13 for the appropriate power down sequence and timing requirements. Once activated, THERMTRIP# remains latched until RESET# is asserted. While the assertion of the RESET# signal will de-assert THERMTRIP# , if the processor's junction temperature remains at or above the trip level, THERMTRIP# will again be asserted after RESET# is de-asserted.
